Physico-Chemical Characteristics of Tailings from Gango Gold Mine

Antonio Y. Asoy ¹, Ronnie L. Besagas ^{2*}, Romeo M. Del Rosario ³
and Noel T. Dael ⁴

Abstract: The physico-chemical characteristics of the Gango gold mine tailings and the economic feasibility of reprocessing it was investigated. Characterization was made in two categories of tailings: the surface tailings and the 1m deep tailings. The results showed that both surface and 1m deep tailings are alkaline at pH 9.80 and 8.98, respectively. Ignition at 500°C resulted in a minimal loss of weight for both surface and 1m deep tailings implying that the tailings contain only a traced amount of volatile substances. The sulfur content of the tailings is at the average of 2.03%. The presence of sulfur may trigger a harmful environmental condition called acid mine drainage. Substantial amount of Fe, Mn, Cr, Cu, Co, Pb, Ag, and Au were assayed in the Gango gold mine tailings. In terms of the economic aspect, the tailings contain substantial amount of gold (7.38 g Au/t) with significant economic value. It is estimated that the tailings pond at Gango Gold Mine contains more than 945 kg of gold. Reprocessing of Gango gold mine tai

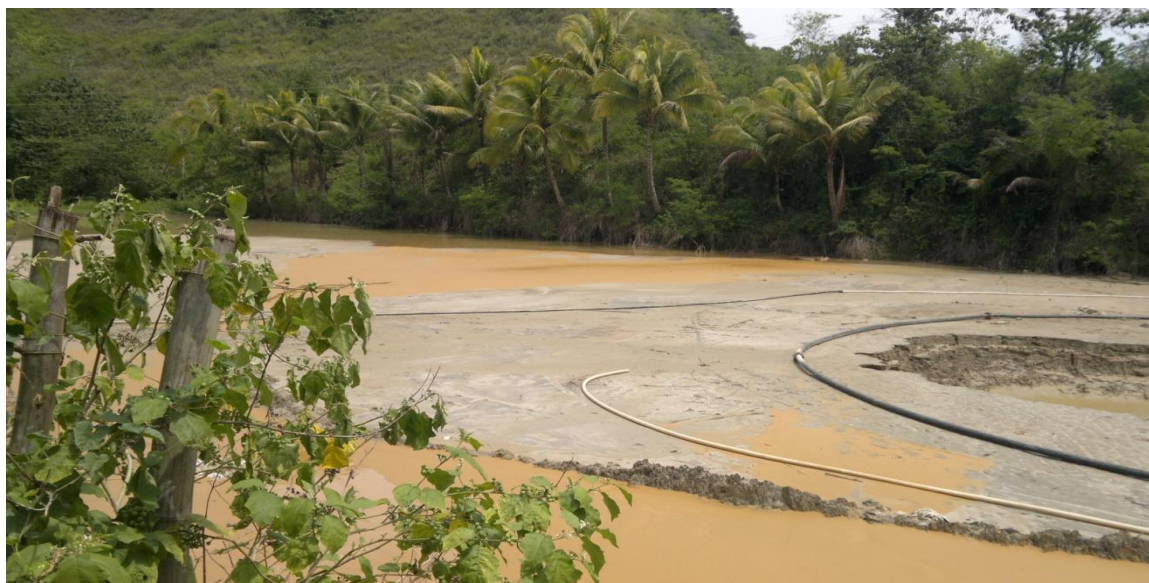
Figure 1: The gold mine tailings pond at Sitio Manlauyan, Gango, Libona, Bukidnon, Philippines.

The tailings were taken from the tailings pond of Gango Gold Mine. Enough quantity of tailings had been taken from the site that will suffice for the various analytical determinations. There were 15 sampling spots that were identified in which both surface tailings and tailings within 1 meter deep were obtained. Then the 15 samples for each surface and 1 meter deep tailings were mixed to obtain two composite samples that are representative to the entire tailings pond from the surface up to a depth of 1 meter. The tailings samples were placed in sealed plastic bags. **Figure 1** shows a picture of the tailings pond.
